*Monitoring Completed Navigation Projects Program*

## **Periodic Inspection of St. Paul Harbor Breakwater, Alaska**

Robert R. Bottin, Jr., and Alan C. Jeffries

February 2001

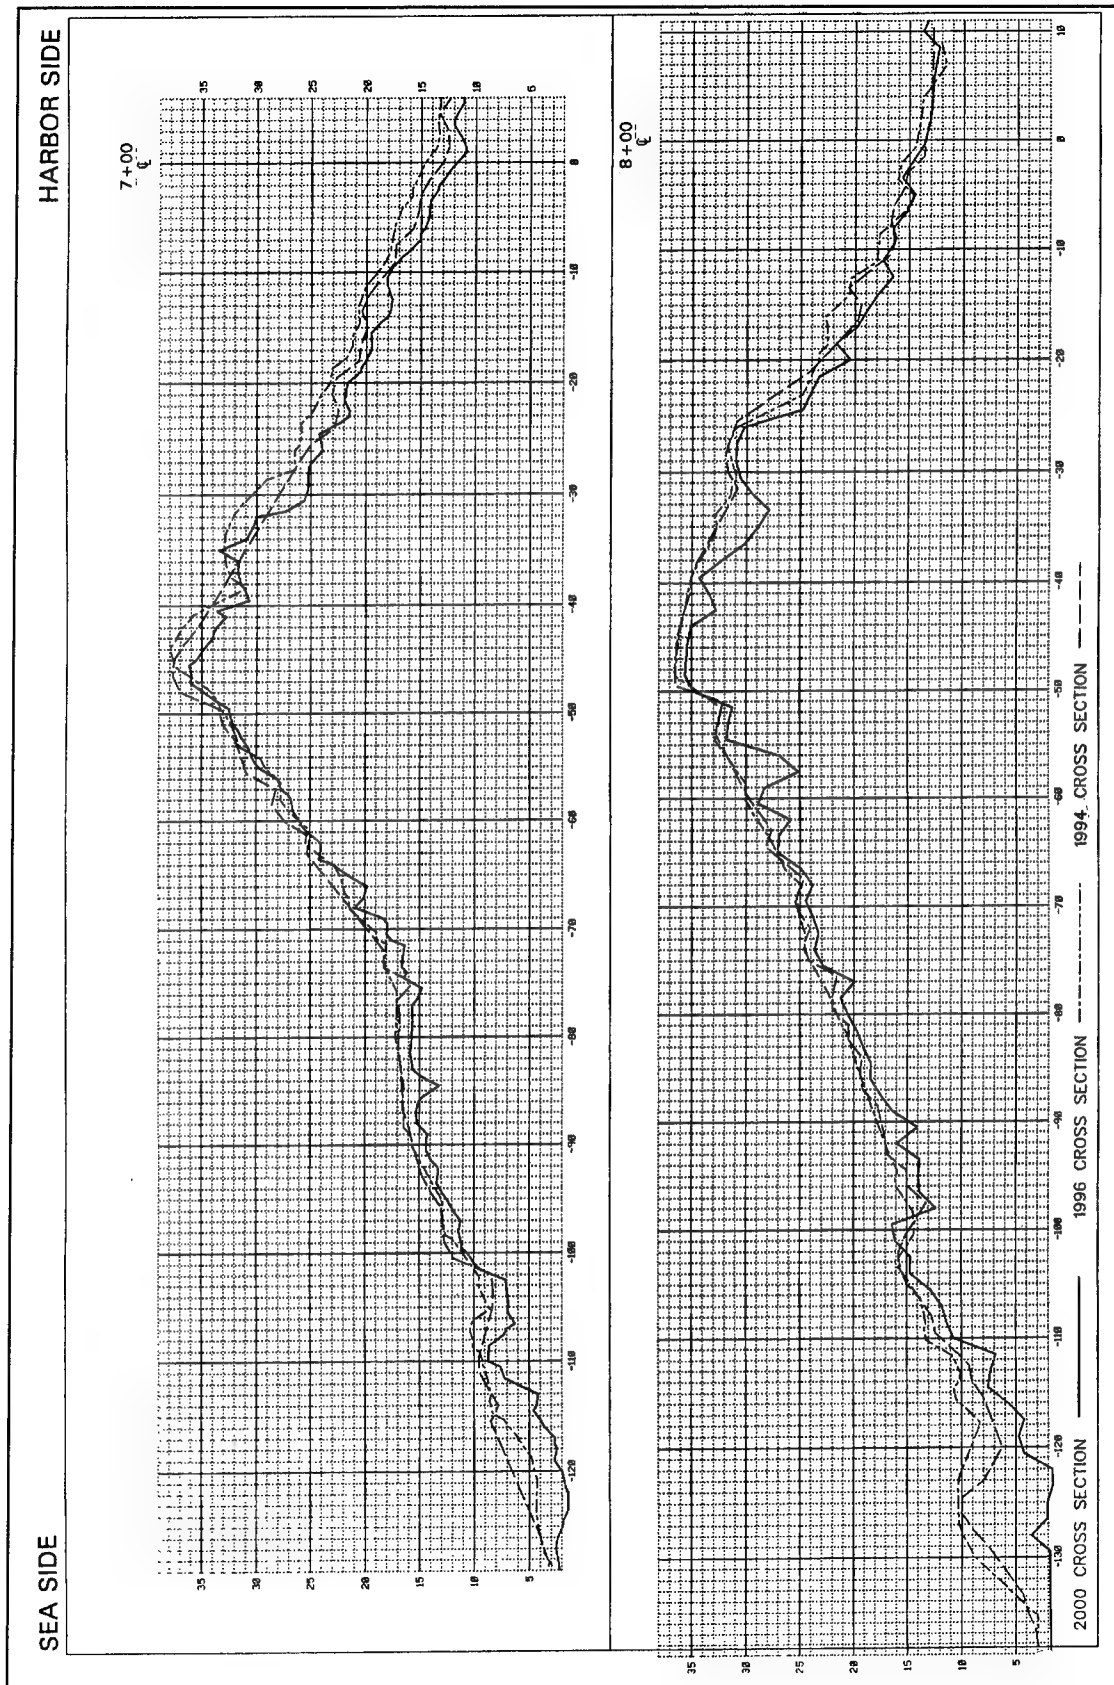
Figure B1. Cross sections of St. Paul Harbor main breakwater, stas 7+00 and 8+00

Examination of breakwater cross sections (Appendix B) reveals low areas in the breakwater based on data obtained in 2000 versus that of 1994 and 1996. The overall shape and elevation of the structure appear to be generally the same, but voids were noted in most cross sections of the current (2000) survey that were not present in the previous ones. Some of these voids were located on the crest of the structure and others along the slopes. The breakwater appears to have lost stones in these low areas.

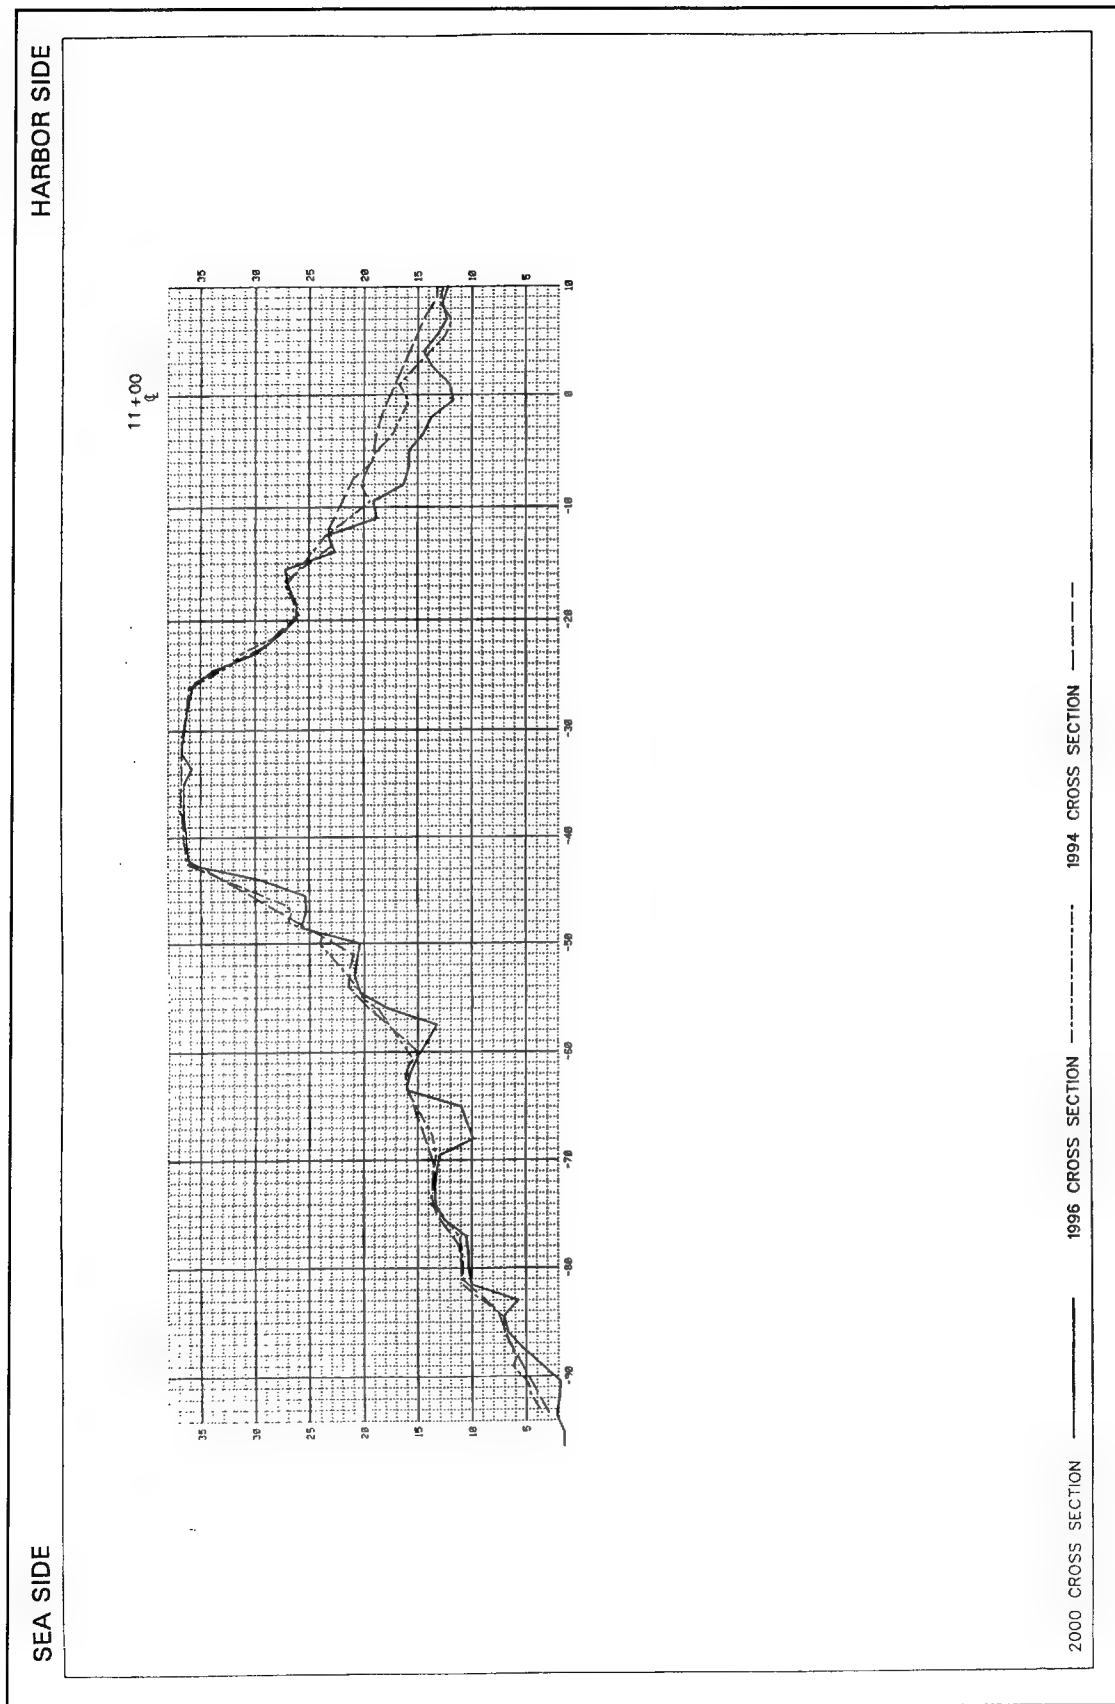
Figure B3. Cross sections of St. Paul Harbor main breakwater, sta 11+00

Examination of cross section data revealed that cross sections of the breakwater were similar in both 1994 and 1996. Accretion of stone along the toe of the harbor side slope of the structure was apparent at stas 11+00, 12+00, and 13+00. This was an accumulation of small stones which was noted during a site visit in 1996. It is not known if this was core stone moving out of the breakwater due to wave action or loose stone moving over and/or through the voids of the structure during storms.
